EXPLOSIVE DEMOLITION AWARD

Country Australia

Australian blast

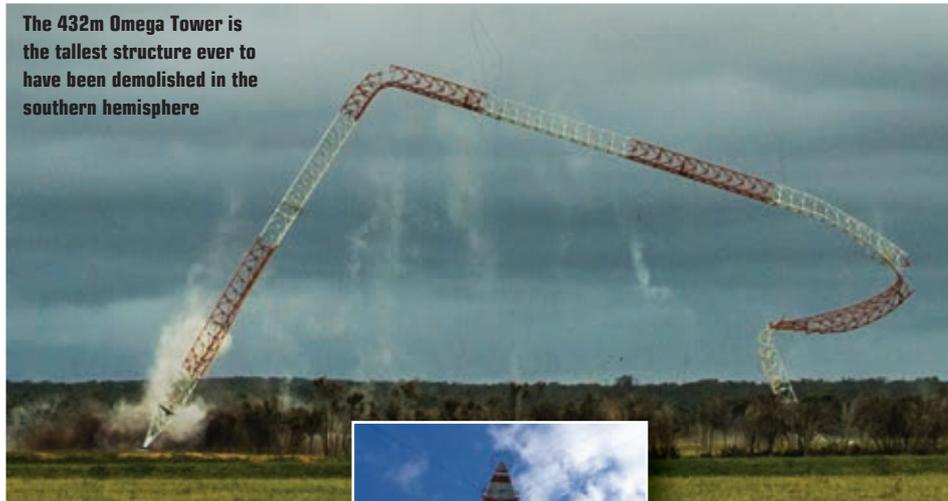
The 432m Omega Tower is the tallest structure ever to have been demolished in the southern hemisphere

Standing 432 m (1,418 ft) high, the Omega Transmission Tower in Darriman, Victoria, Australia was the tallest structure in the Southern Hemisphere until its demolition on 22 April 2015. Contracted by the Australian government's Department of Defence to carry out the demolition, Liberty Industrial used controlled explosive techniques to bring the redundant naval communications tower to the ground.
