# OMEGA TOWER DEMOLITION.

**Location**  
Derriman, Victoria

**Client**  
Department of Defence

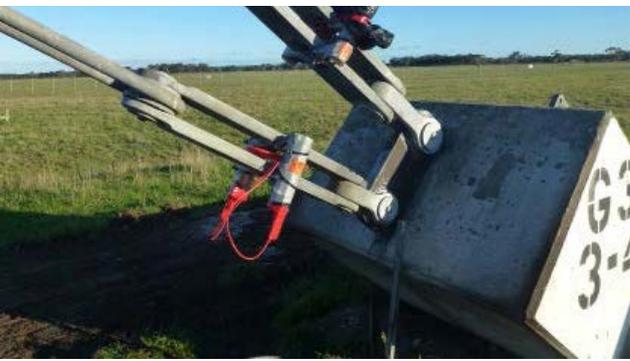
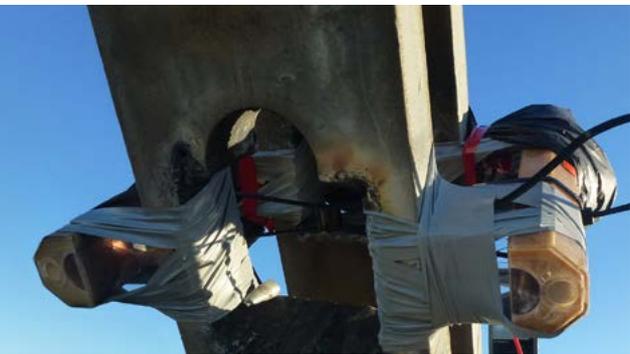
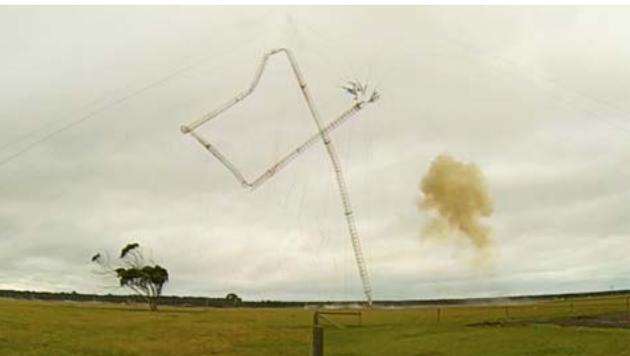
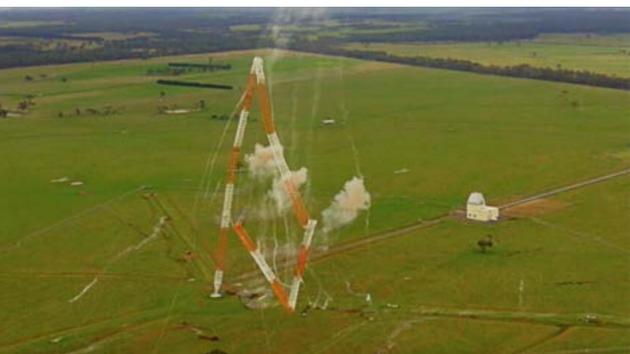
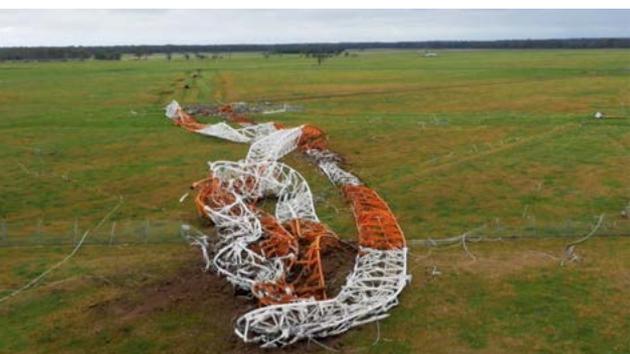
We tested the available explosives on steel plates fabricated to replicate the cable support stay plates we were planning to sever with the cutting charges

to determine exactly what depth they could confidently cut through. After the testing we were satisfied that we could at least sever 50mm thick plates with the Comp B explosives charges. However, to ensure that we had some redundancy in the charges we decided to undertake preparatory oxy cutting on the cable stay support plates to ensure we had a maximum of 40mm thick steel to cut. With some of the cable stay support plates up to 80mm thick at the outer most support, we utilised GHD Engineering, our preferred Structural Engineering company, to complete a full structural review on the tower and its support stays, to develop a preparatory cutting scheme that ensured we had no steel thicker than 40mm to explosively cut, whilst ensuring the tower remained structurally sound until the cutting charges were initiated.
