# ENEABBA MINERAL SANDS MINE PRE-CONCENTRATOR PLANT DEMOLITION.

**Location**  
Eneabba, WA

**Client**  
Iluka Resources

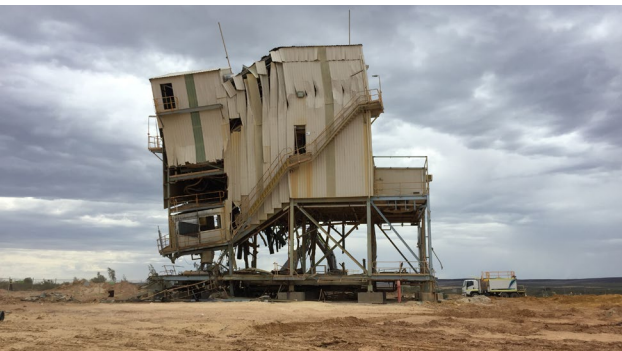
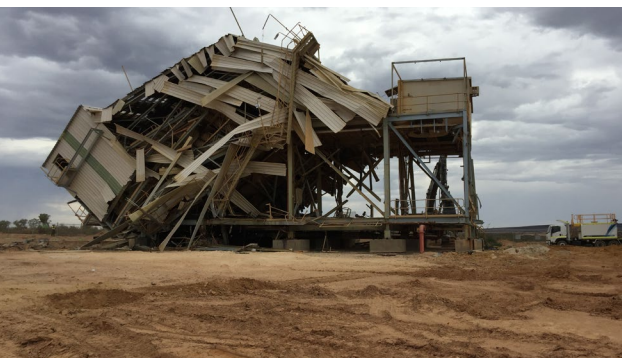
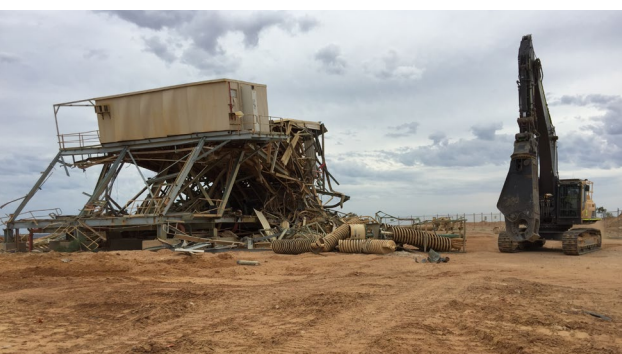
The demolition of the four storey pre concentrator steel structure was conducted using a controlled collapse of the structure as seen below. Other works included the removal of salvage items, the demolition and removal of loose plant and equipment adjacent the pre-concentrator, demolition and removal of three above ground storage tanks, demolition and removal of plinth foundations and tank foundations.
